# **INDOOR AIR QUALITY ASSESSMENT**

**Boston Public Library  
Upham's Corner Branch  
500 Columbia Road  
Dorchester, Massachusetts**

Prepared by:  
Massachusetts Department of Public Health  
Bureau of Environmental Health  
Indoor Air Quality Program  
January 2018

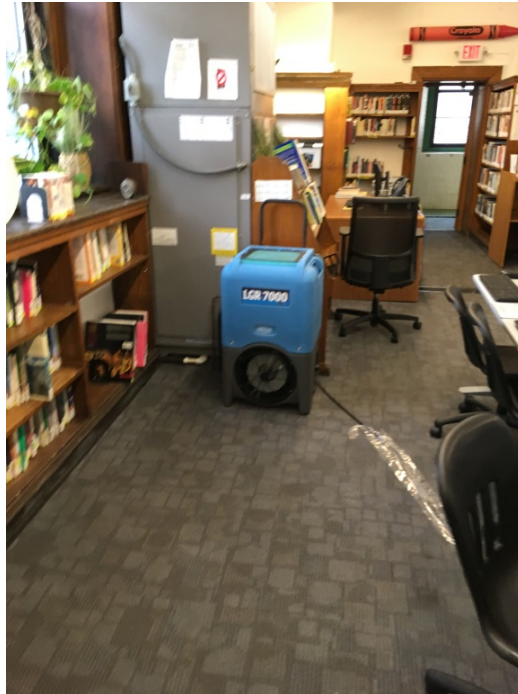
**Picture 1**

The UC does not have a mechanical ventilation system that provides fresh air. The original natural gravity ventilation system that was part of the building when it was constructed in 1903 was abandoned and sealed. The sole source of fresh air in the UC is openable windows. The UC is equipped with two free standing air handling units (AHUs) that provide air conditioning in hot humid weather only (Picture 1).

**AHU with dehumidifier in the foreground**

2. Since the UC has an abandoned gravity vent system, any remaining vents on both levels should be sealed.
3. Use openable windows for fresh air; however keep windows closed when air conditioning is operating.
4. Improve drainage from the cement-lined pit and access ramp. Installation of an awning to protect the access ramp from heavy rains should be considered.
5. Refer to resource manual and other related IAQ documents located on the MDPH's website for further building-wide evaluations and advice on maintaining public buildings. These documents are available at: <http://mass.gov/dph/iaq>.

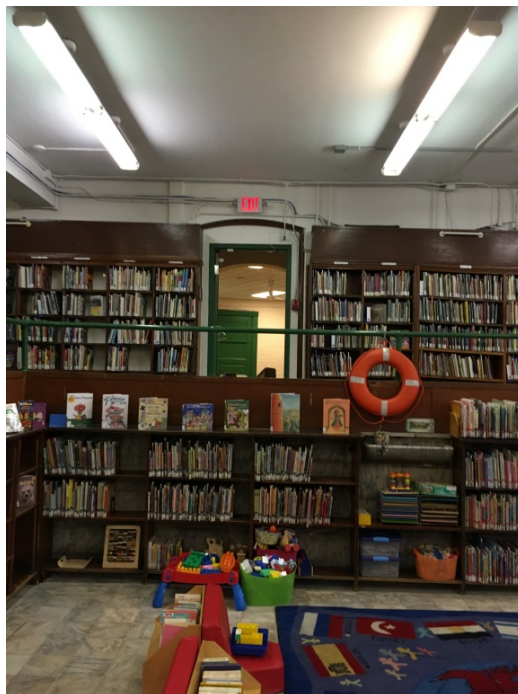
**Picture 2**

As noted previously, the lower level of the library was formerly an indoor pool that was constructed in 1903 (Picture 2). Along the walls of the former pool are four basins that have drains (Pictures 3 and 4). The floor of the pool also has drains (Picture 5). The purpose of each drain was to remove standing water from the floors as well as to maintain the level of water in the pool. Due to the age of the building, it is likely that none of the drains have a trap. The purpose of the trap is to prevent air from the sewer system from backing up the drains into occupied space. Traps work by holding water in the u-bend of a pipe which forms an airtight seal. If the trap has no water in its u-bend or no traps exist in the pipe, odors from the sewer can enter. Rain can cause surcharging of sewers leading to a greater likelihood of odors inside. UC staff reported that odors are noticeable in the children's area during rainstorms.

**Children's room, the marble floor was originally the bottom of the indoor pool**

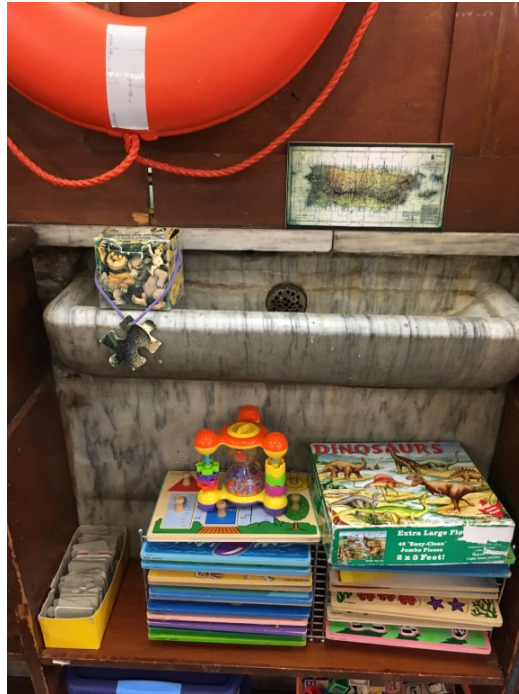
**Picture 3**

**Basin in wall of pool**

1. Seal all unused drains in the children's room.

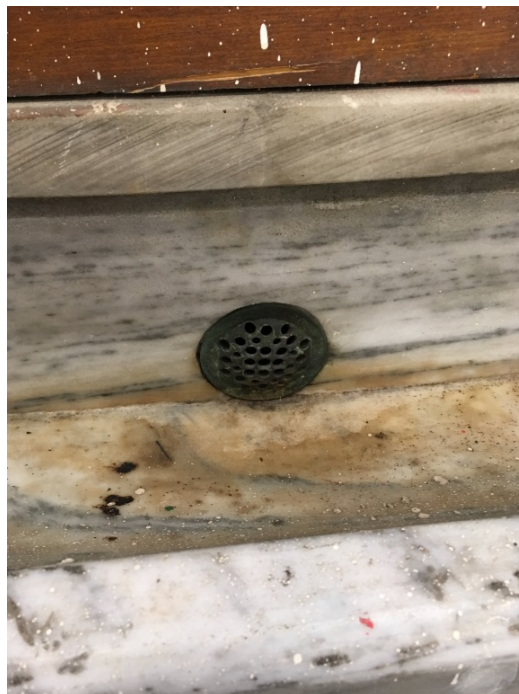
**Picture 4**

**Open drain in basin**

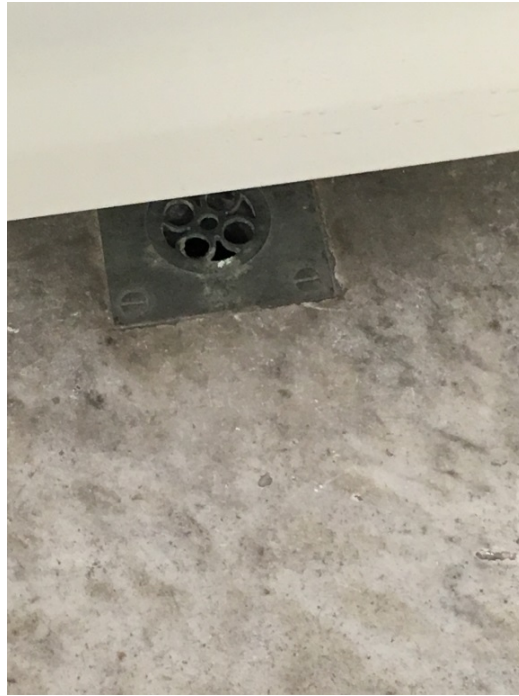
**Picture 5**

**Floor drain**

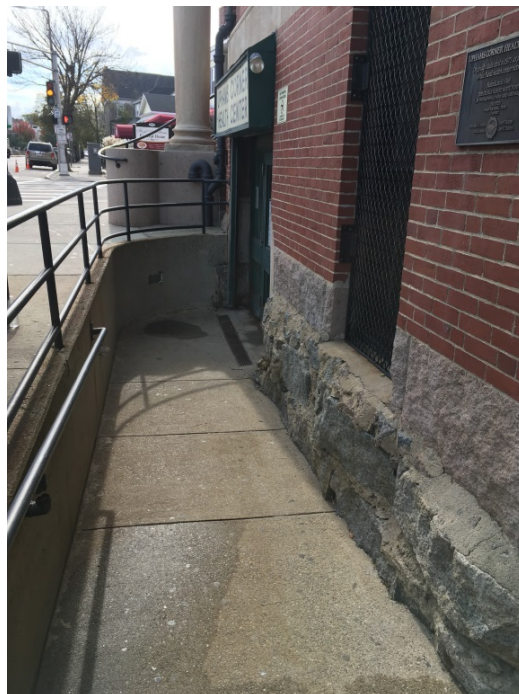
**Picture 6**

UC staff also report that the ground floor has become flooded after heavy rains. Outside the windows of the library is a cement pit with a drain. In addition, the clinic on the ground floor has a ramp that has an interceptor drain in front of the door (Picture 6). If rainfall exceeds the capacity for drains, water can fill up in the cement lined pit as well as the bottom of the access ramp which then can enter the interior of the building through the exterior access door. Given that increasing the drainage capacity would be a major project, means to prevent water from accumulating within each structure should be considered.

**Interceptor drain at bottom of ramp in front of health center door**
